The EEP began restoration efforts in 1996 at the Alloway Creek Watershed *Phragmites*-dominated Wetland Restoration Site, located in Elsinboro and Lower Alloways Creek Townships, Salem County, New Jersey. The restoration area encompasses 1,601 acres of the 3,096-acre site. The site is subject to tidal influence from the Delaware River and Alloway Creek. Wetland enhancement and restoration efforts were completed in 1999. Restoration has transformed more than 800 acres from *Phragmites* vegetation to desirable plant species.

ALLOWAY CREEK WATERSHED SITE

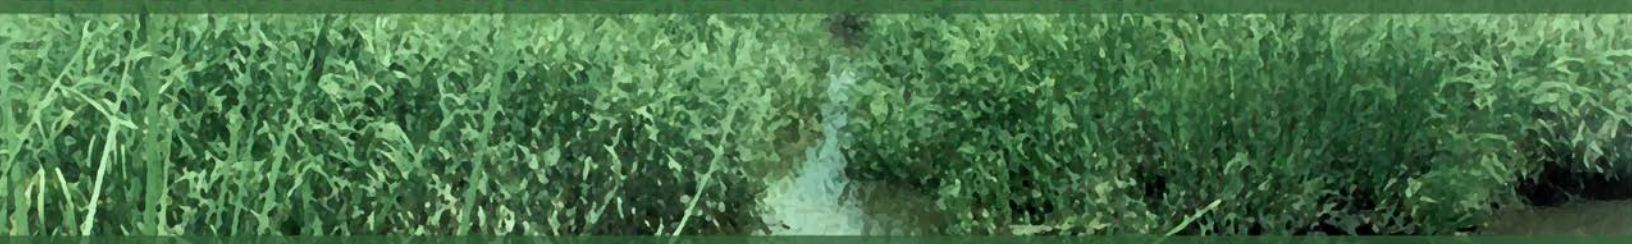
Alloway Creek Watershed Wetland Restoration Site Vegetative Cover Summary Chart

Prior to restoration activities, *Phragmites* (yellow line) dominated nearly 60% of the Alloway Creek Watershed *Phragmites*-dominated Wetland Restoration Site. Herbicide applications and removal of dead culms resulted in a rapid decline in *Phragmites*. As the *Phragmites* declines and the drainage improved, *Spartina* (green line) re-vegetated the area. The red line (linear feet of channel per acre) indicates the increased aquatic habitat at this site.

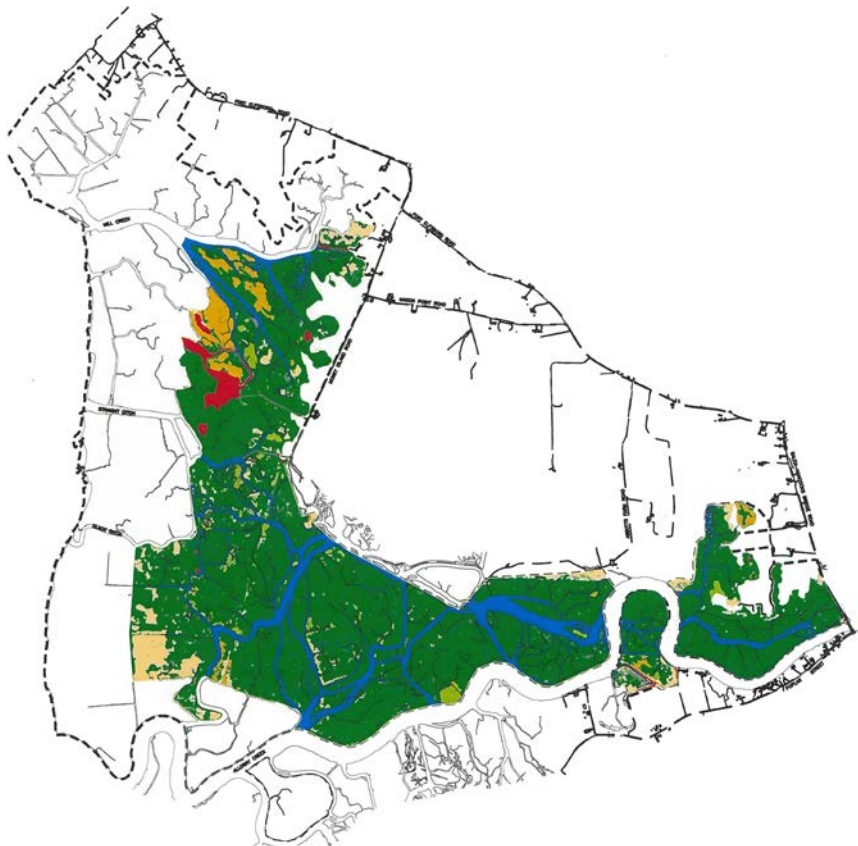
Alloway Creek Watershed Site – 2016 Vegetation

After implementation of *Phragmites* controls, *Phragmites* coverage (tan shaded areas) substantially declined, drainage improved and *Spartina* (green shaded areas) re-vegetated the site.
