### Overview

The 1,055-acre Cohansey River Watershed *Phragmites*-dominated Wetland Restoration Site, located in Fairfield and Hopewell Townships, Cumberland County, New Jersey, encompasses approximately 910 acres of previously impounded coastal marsh, adjacent freshwater wetlands and upland areas. Wetland enhancement and restoration efforts began in 1996, and concluded in 1999.

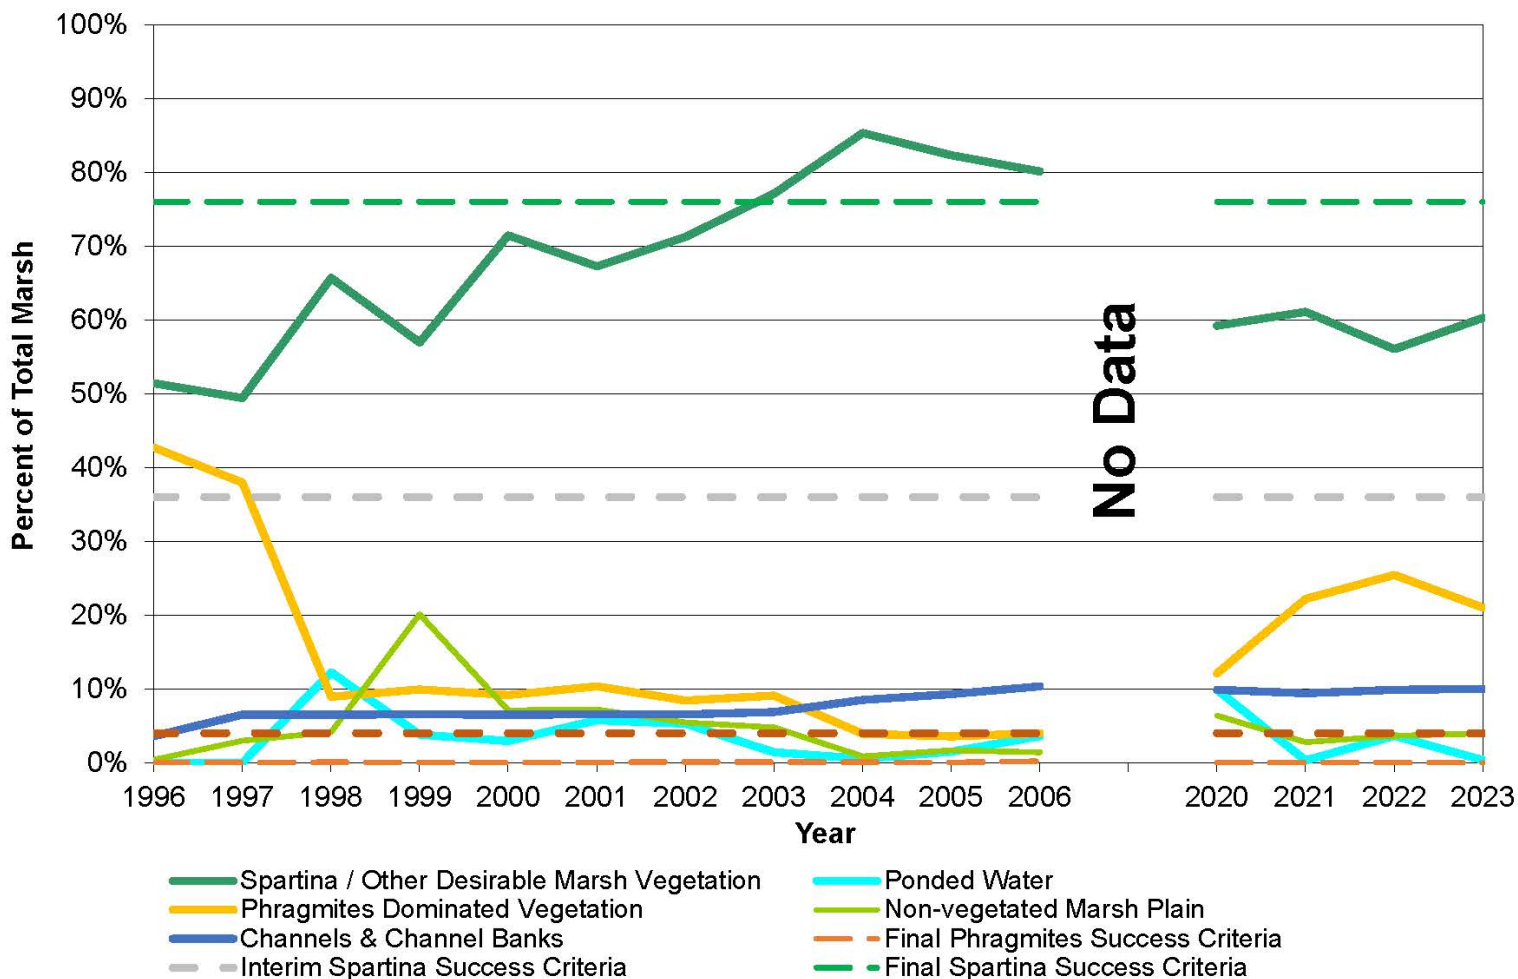
**Cohansey River Watershed Wetland Restoration Site  
Wetland Restoration Area Cover Category Summary 1996 - 2006; 2020 - 2023**

Prior to restoration both *Spartina* (green line) and *Phragmites* (yellow line) co-dominated the Cohansey River Watershed *Phragmites*-dominated Wetland Restoration Site. As *Phragmites* was treated with herbicide and the dead culms were removed, the population plummeted and tidal flushing improved. *Spartina* now dominates 85% of the wetland. The red line (linear feet of channel per acre) indicates the increased aquatic habitat at this site.

Note: Due to low Percent of Total marsh area values (e.g. <1.0%), some categories may not show clearly on chart.

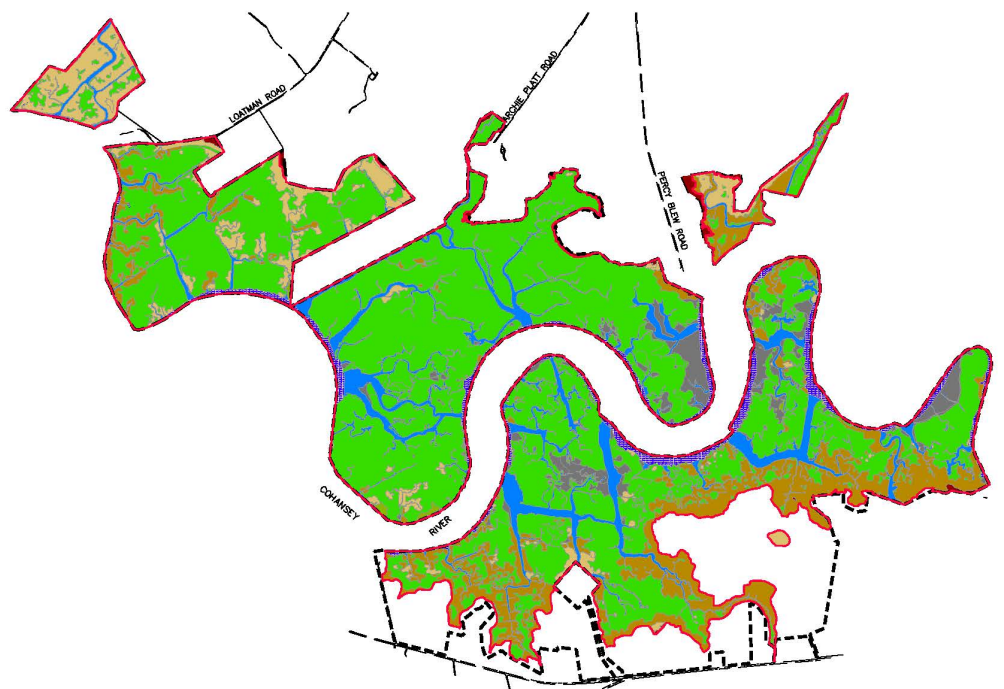
### Cohansey River Watershed Site – 2023

After implementation of controls, the *Phragmites* (tan shaded areas) was nearly eliminated and *Spartina* (green shaded areas) coverage expanded into areas formerly covered by *Phragmites*.
