Cedar Swamp is a 1,870-acre site, which includes a 1,863-acre restoration are, in New Castle County, Delaware. The site is owned by DNREC and Delaware Wildlands. Historically, the site was used for hunting and included a coastal recreation resort. Phragmites covered approximately 72 percent of the vegetated marsh plain before initiation of restoration activities. In addition to public hunting and wildlife observation, the Cedar Swamp site is currently used as an anchorage for commercial and recreational crabbing and fishing boats. Restoration has added more than 1,180 acres of desirable plant species and has reduced the Phragmites coverage to less than 8 percent. Wetland enhancement and restoration efforts began in 1995, and were completed in 2000.

Cedar Swamp Wetland Restoration Site Vegetative Cover Summary Chart

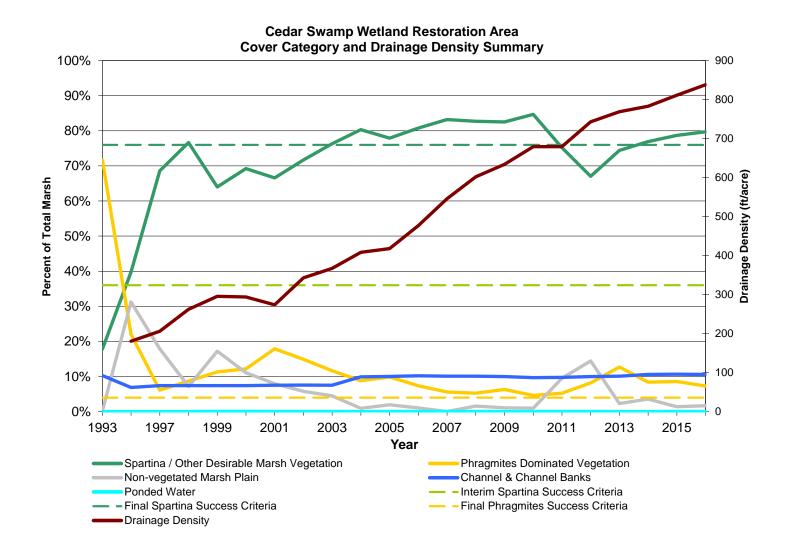
Phragmites (yellow line) dominated the wetland site prior to restoration activities; however, a rapid decline in the population followed herbicide treatments. As the *Phragmites* declined, *Spartina* (green line) was able to re-vegetate the area. The red line (linear feet of channel per acre) indicates the increased aquatic habitat at this site.

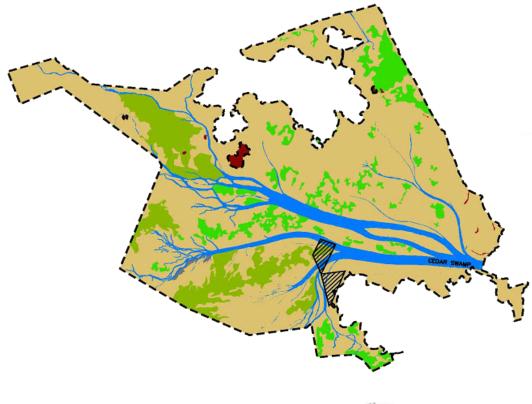
Cedar Swamp Site - 1993

As shown by the tan shaded area, the Cedar Swamp Phragmites-dominated Wetland Restoration Site was dominated by Phragmites prior to restoration activities. Only scattered areas of Spartina and other desirable marsh vegetation (green shaded areas) were initially present.

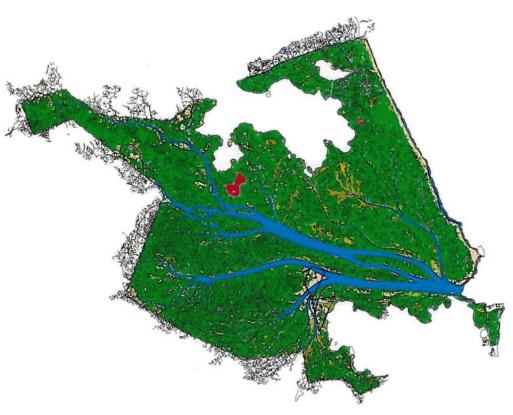
Cedar Swamp Site - 2016

After control activities were implemented, the *Phragmites* (tan shaded areas) population declined and the site is now dominated by *Spartina* (green shaded areas).
