### Overview

The EEP began restoration efforts in 1996 at the Alloway Creek Watershed *Phragmites*-dominated Wetland Restoration Site, located in Elsinboro and Lower Alloways Creek Townships, Salem County, New Jersey. The restoration area encompasses 1,601 acres of the 3,096-acre site. The site is subject to tidal influence from the Delaware River and Alloway Creek. Wetland enhancement and restoration efforts were completed in 1999.

## ALLOWAY CREEK WATERSHED SITE

### Alloway Creek Watershed Wetland Restoration Site Vegetative Cover Summary Chart

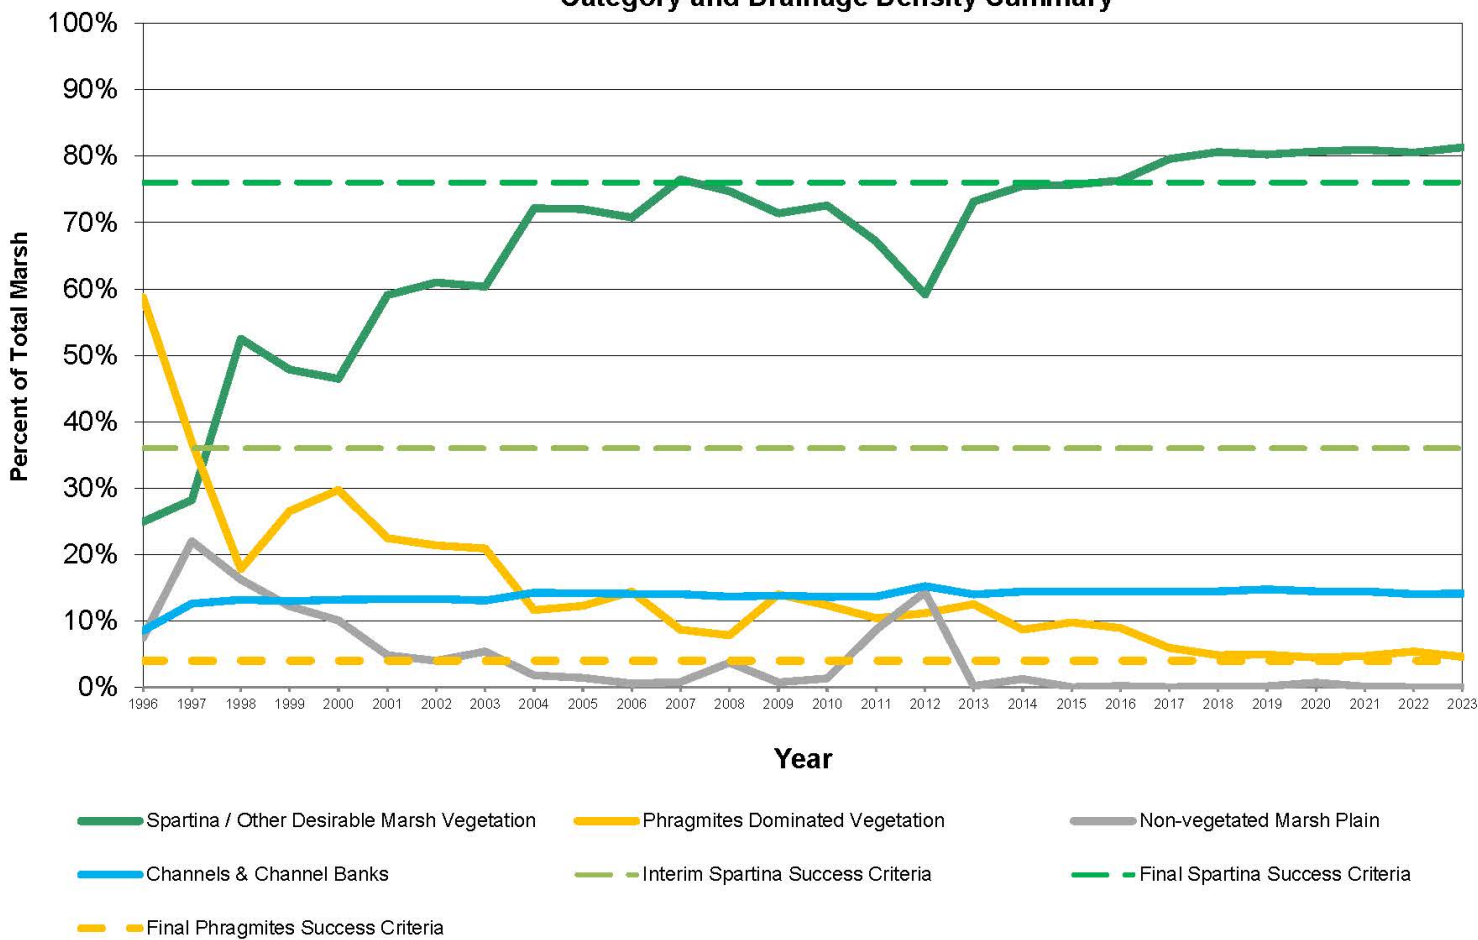
Alloway Creek Watershed Wetland Restoration Site Cover Category and Drainage Density Summary

Prior to restoration activities, *Phragmites* (yellow line) dominated nearly 60% of the Alloway Creek Watershed *Phragmites*-dominated Wetland Restoration Site. Herbicide applications and removal of dead culms resulted in a rapid decline in *Phragmites*. As the *Phragmites* declines and the drainage improved, *Spartina* (green line) re-vegetated the area. The red line (linear feet of channel per acre) indicates the increased aquatic habitat at this site.

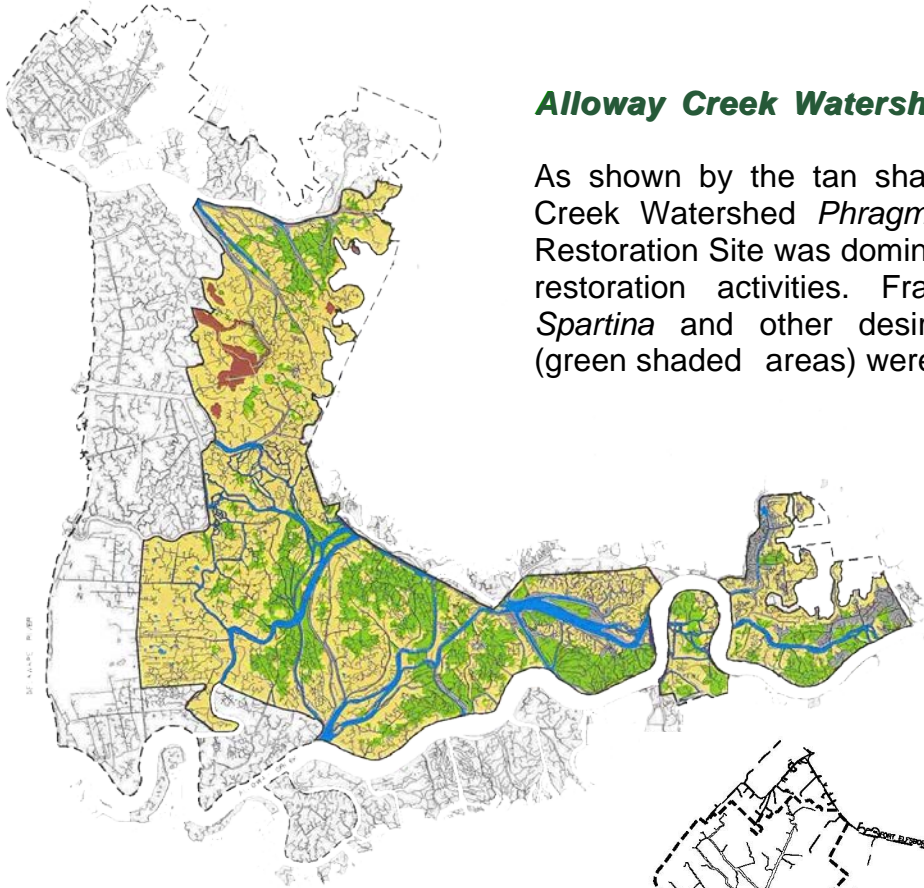
### Alloway Creek Watershed Site – 1996

As shown by the tan shaded areas, the Alloway Creek Watershed *Phragmites*-dominated Wetland Restoration Site was dominated by *Phragmites* prior to restoration activities. Fragmented areas of *Spartina* and other desirable marsh vegetation (green shaded areas) were present in some areas.

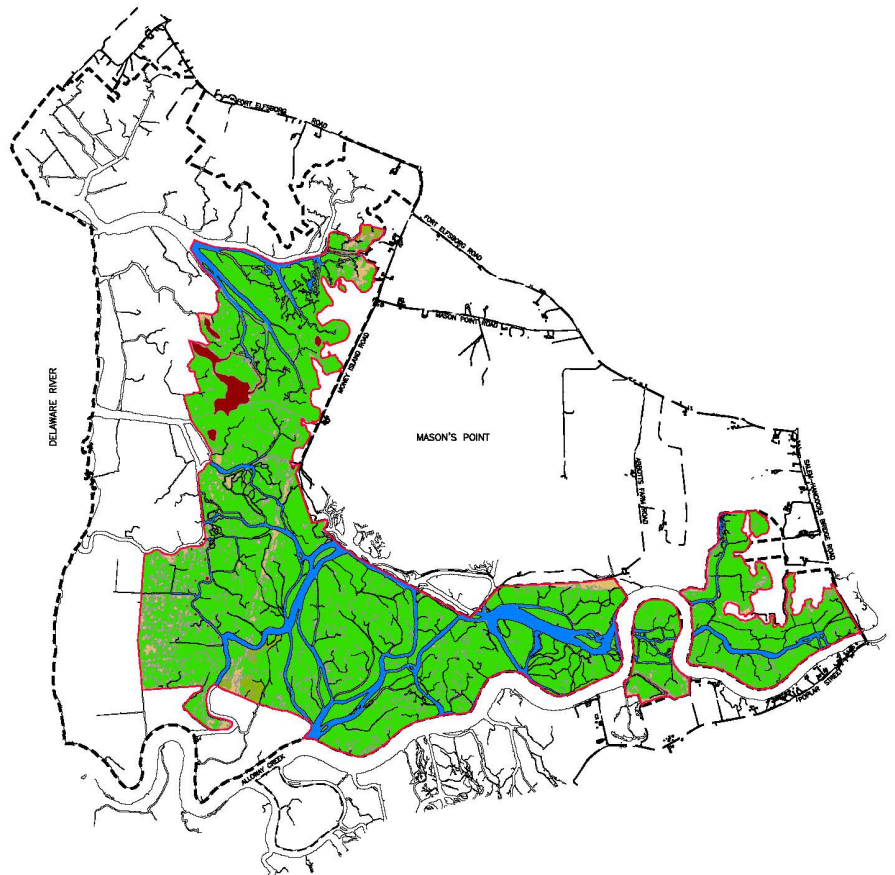
### Alloway Creek Watershed Site – 2023

After implementation of *Phragmites* controls, *Phragmites* coverage (tan shaded areas) substantially declined, drainage improved and *Spartina* (green shaded areas) re-vegetated the site.
