### Overview

### Cohansey River Watershed Wetland Restoration Site Vegetative Cover Summary Chart

## COHANSEY RIVER WATERSHED SITE

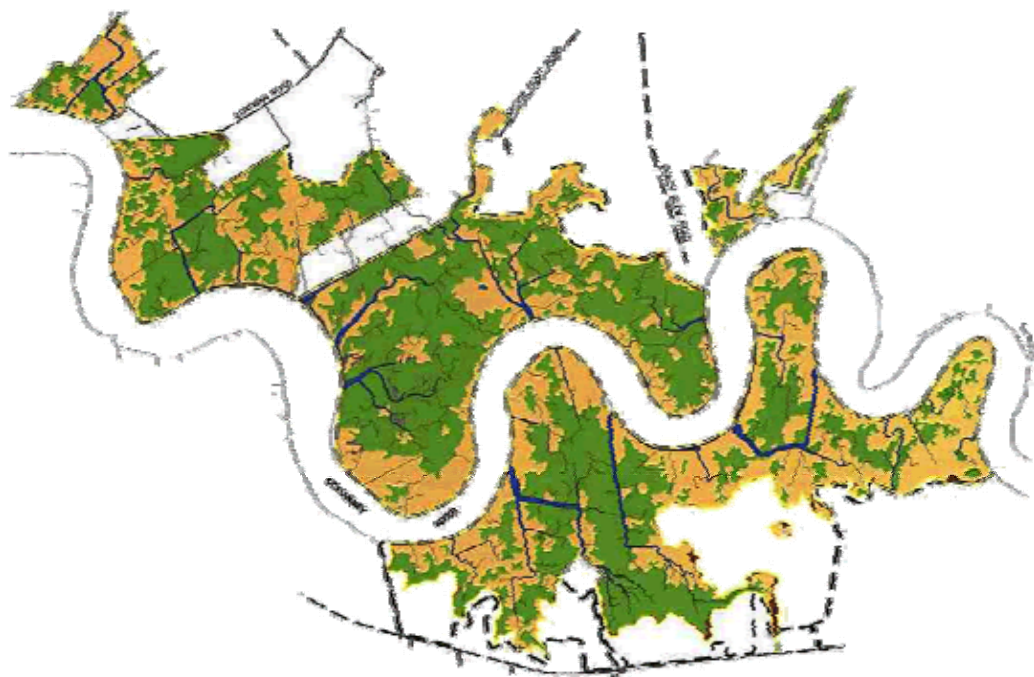
### Cohansey River Watershed Site – 1996

As shown by similar abundances of the tan and green shaded areas, *Phragmites* (tan shaded areas) and *Spartina* (green shaded areas) co-dominated the site prior to restoration.

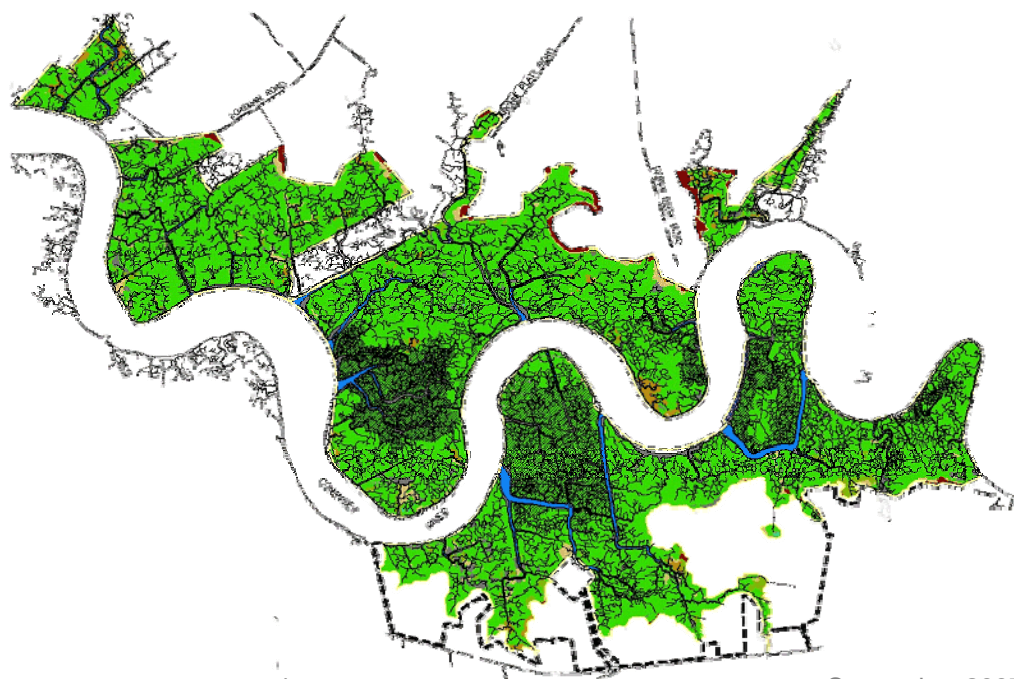
### Cohansey River Watershed Site – 2005

After implementation of controls, the *Phragmites* (tan shaded areas) was nearly eliminated and *Spartina* (green shaded areas) coverage expanded into areas formerly covered by *Phragmites*.
