Overview

Cedar Swamp is a 1,870-acre site, which includes a 1,863-acre restoration area, in New Castle County, Delaware. The site is owned by DNREC and Delaware Wildlands. Historically, the site was used for hunting and included a coastal recreation resort. *Phragmites* covered approximately 72 percent of the vegetated marsh plain before initiation of restoration activities. In addition to public hunting and wildlife observation, the Cedar Swamp site is currently used as an anchorage for commercial and recreational crabbing and fishing boats. Wetland enhancement and restoration efforts began in 1995, and were completed in 2000.

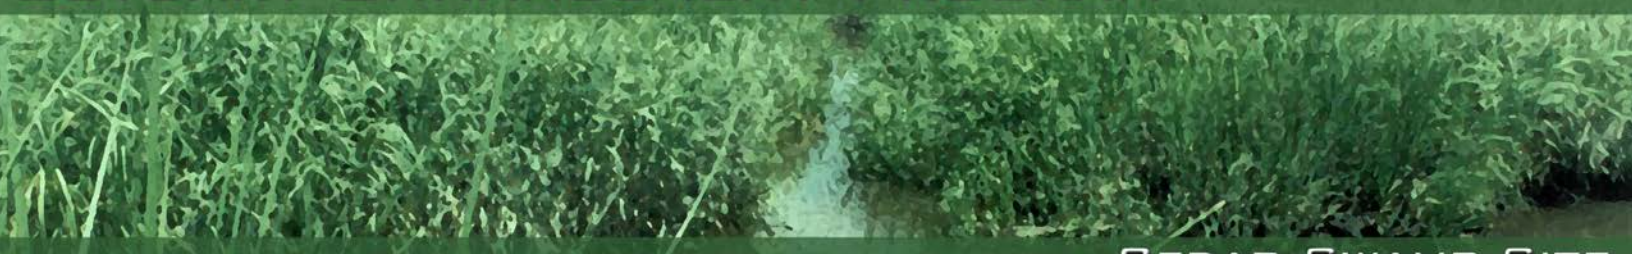
Cedar Swamp Wetland Restoration Site Vegetative Cover Summary Chart

Phragmites (yellow line) dominated the wetland site prior to restoration activities; however, a rapid decline in the population followed herbicide treatments. As the *Phragmites* declined, *Spartina* (green line) was able to re-vegetate the area. The red line (linear feet of channel per acre) indicates the increased aquatic habitat at this site.

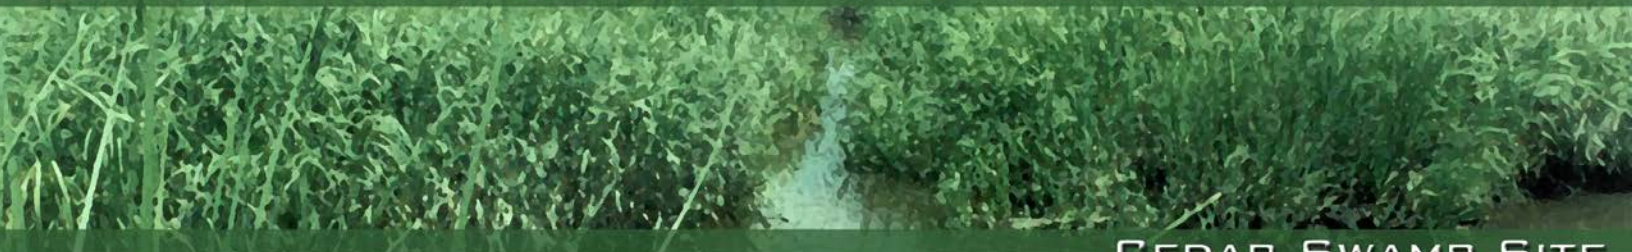
Cedar Swamp Site – 1993

As shown by the tan shaded area, the Cedar Swamp *Phragmites*-dominated Wetland Restoration Site was dominated by *Phragmites* prior to restoration activities. Only scattered areas of *Spartina* and other desirable marsh vegetation (green shaded areas) were initially present.

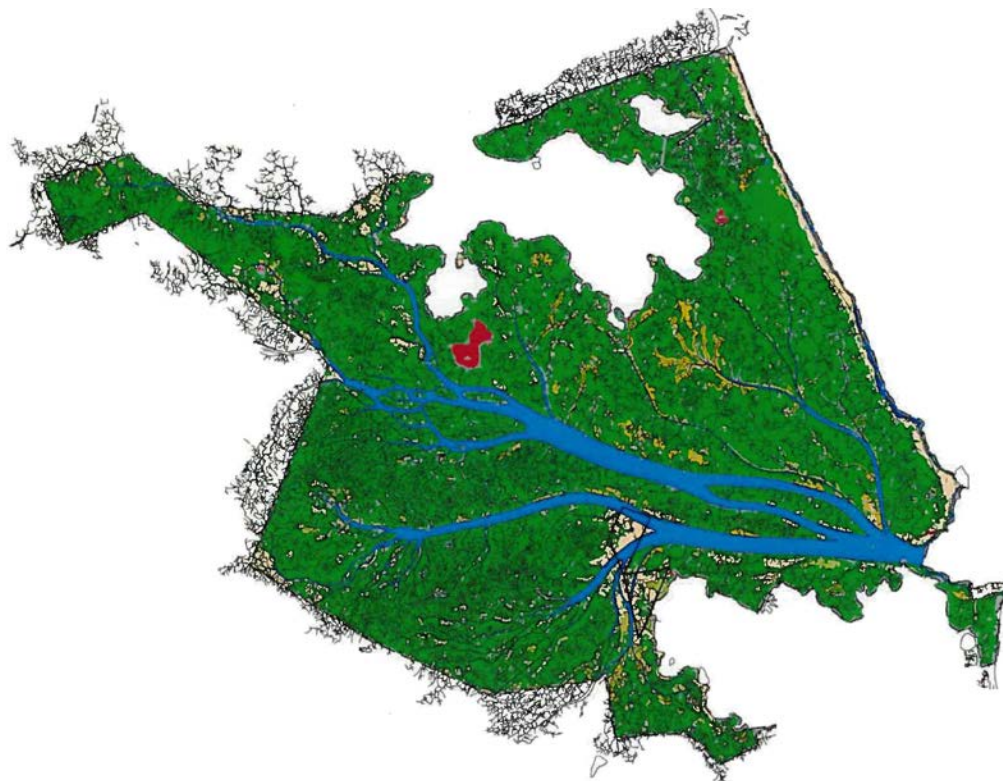
Cedar Swamp Site – 2016

After control activities were implemented, the *Phragmites* (tan shaded areas) population declined and the site is now dominated by *Spartina* (green shaded areas).
