Located in Cumberland County, New Jersey, the Maurice River Township Salt Hay Farm Wetland Restoration Site is a 1,396-acre site, which includes a wetland restoration area of 1,135 acres. Historically, a large portion of the farming area was vegetated with salt hay grass. As early as 1810, perimeter dikes were constructed and water control structures were installed to eliminate normal tidal inundation over the area. Large stands of *Phragmites* were present prior to restoration activities. Wetland enhancement and restoration efforts began in 1996, and were completed in 1998, producing marsh, indistinguishable in function and appearance, from natural marsh within 4 years of construction completion.

Maurice River Township Wetland Restoration Site Vegetative Cover Summary Chart

MAURICE RIVER TOWNSHIP SITE

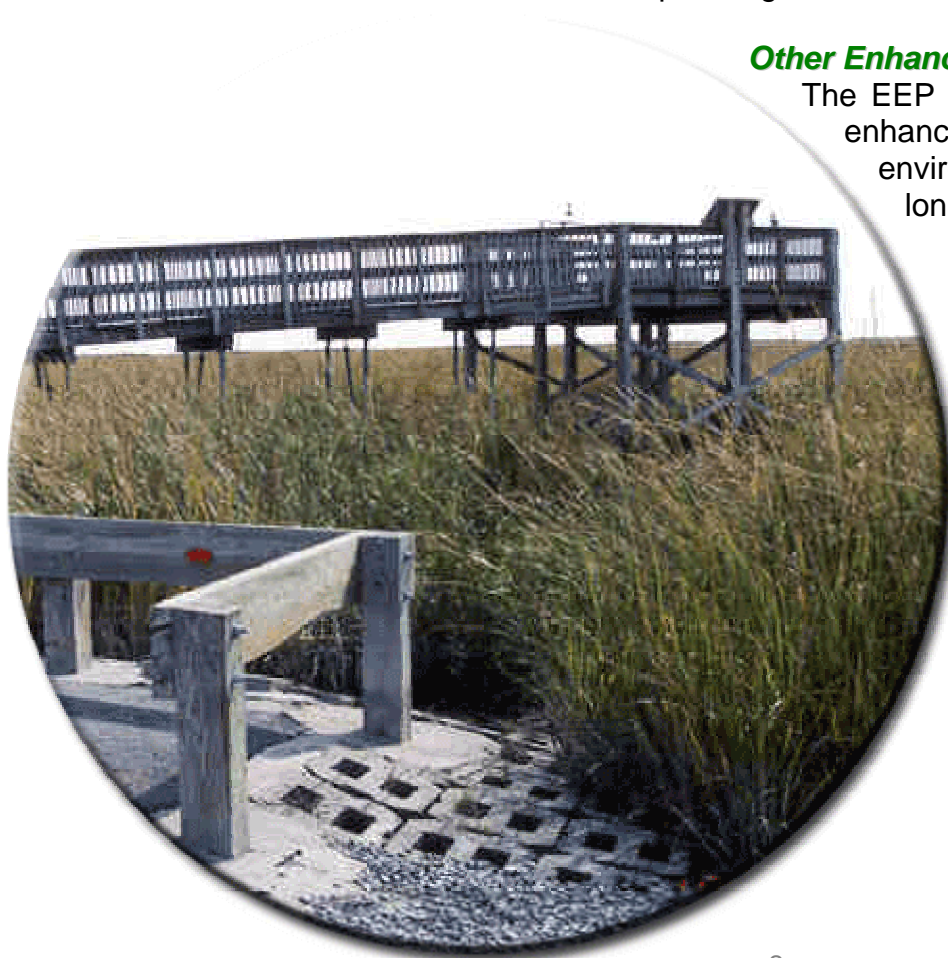
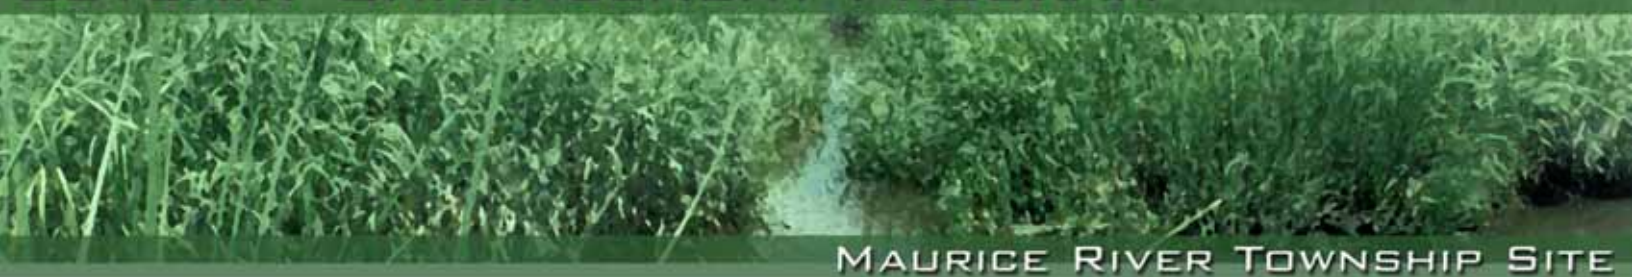
As shown by the limited coverage by *Phragmites* (yellow line) and desirable marsh vegetation (green line), this site was unvegetated marsh plain (grey area below) prior to restoration activities. The construction of channels re-established normal tidal flow. This increased drainage density and allowed *Spartina* to flourish. The red line (linear feet of channel per acre) indicates the increased aquatic habitat at this site.

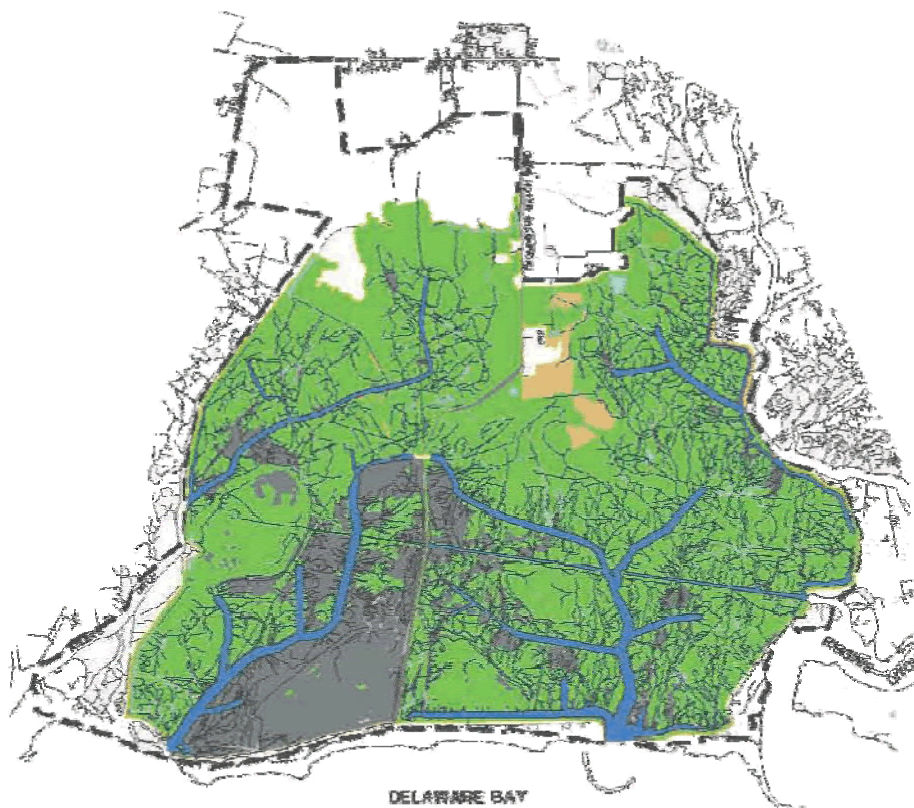
Maurice River Township Site – 2004

The construction of channels restored normal tidal flow to the site. The spread of *Phragmites* (tan shaded areas) was controlled; and *Spartina* (green shaded areas) has re-populated a majority of the former unvegetated marsh plain (grey shaded areas).
