The Rocks, a 736-acre wetland restoration site in New Castle County, Delaware, is part of a continuous tidal marsh community referred to as the Appoquinimink River-Blackbird Creek System that extends north and south for several miles. The site is owned by DNREC. Before restoration, *Phragmites* covered approximately 87 percent of the vegetated marsh plain. Wetland enhancements and restoration efforts began in 1995, and were completed in 2000.

The Rocks Wetland Restoration Site Vegetative Cover Summary Chart

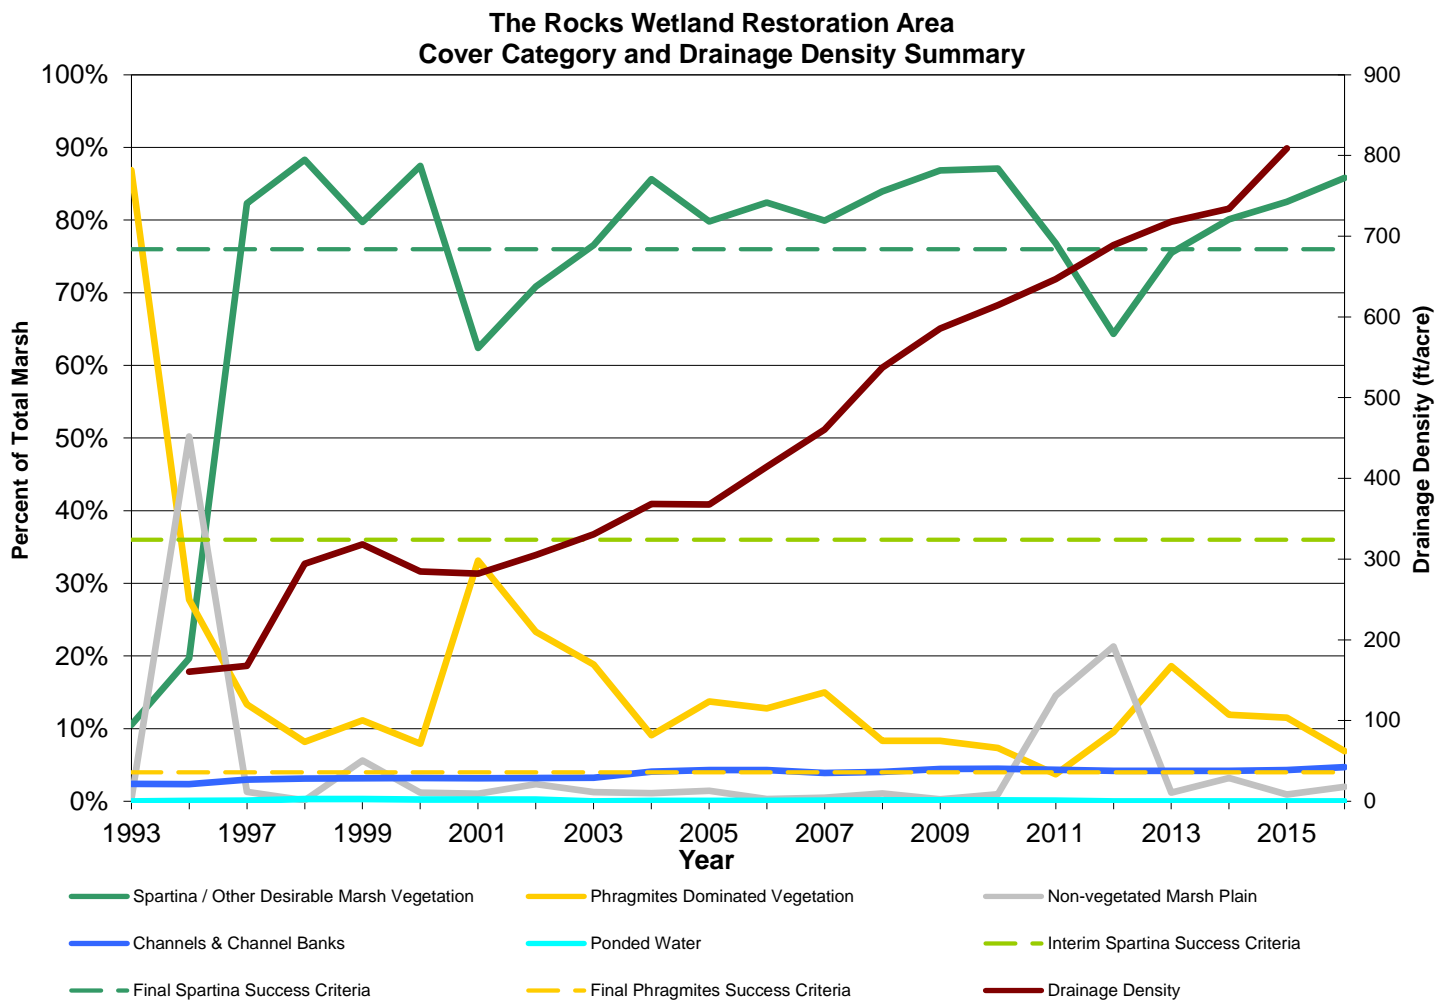
Prior to restoration activities, *Phragmites* (yellow line) covered 87% of the site; *Spartina* (green line) was present in very limited areas. After herbicide applications, *Phragmites* coverage decreased, and was replaced by *Spartina* and mixed stands of desirable species. *Spartina* and other desirable marsh vegetation now dominates more than 70% of the site. The red line (linear feet of channel per acre) indicates the increased aquatic habitat at this site.

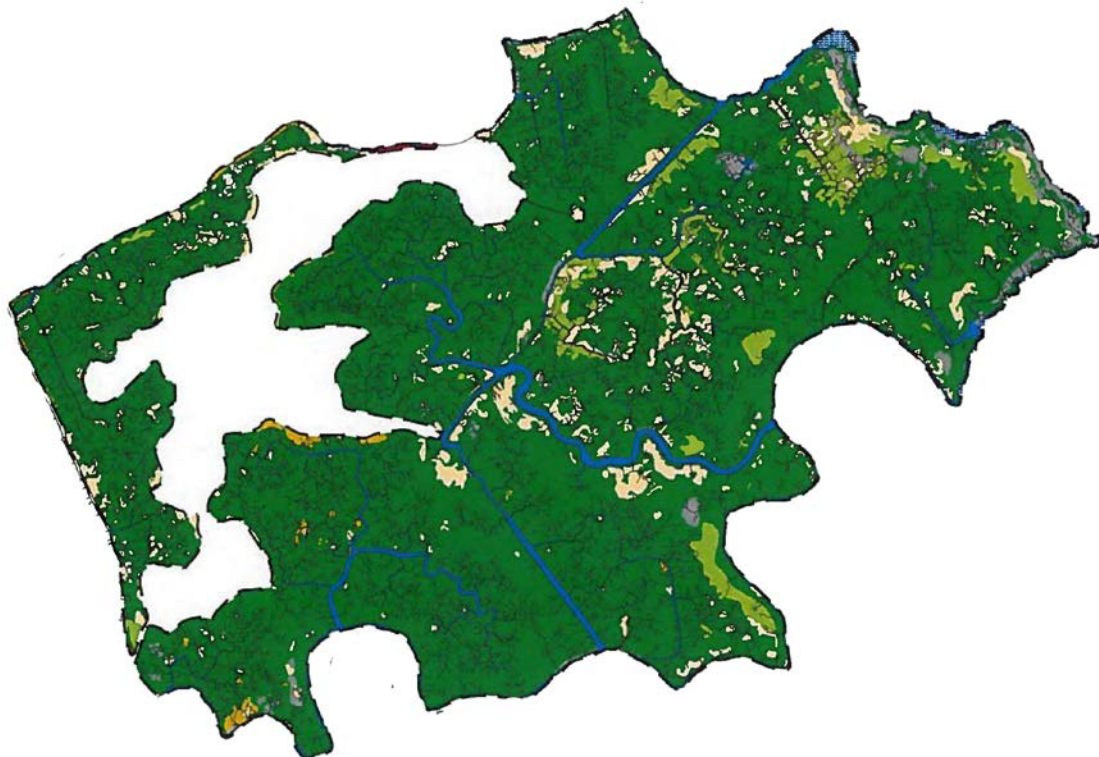
The Rocks Site – 2016

After treatment, the *Phragmites* (tan shaded areas) population declined. With improved drainage, *Spartina* (green shaded areas) increased, and now dominates the site.
