Overview

The Rocks, a 736-acre wetland restoration site in New Castle County, Delaware, is part of a continuous tidal marsh community referred to as the Appoquinimink River-Blackbird Creek System that extends north and south for several miles. The site is owned by DNREC. Before restoration, *Phragmites* covered approximately 87 percent of the vegetated marsh plain. Restoration has added more than 529 acres of desirable plant species and has reduced the *Phragmites* coverage to less than 13 percent. Wetland enhancements and restoration efforts began in 1995, and were completed in 2000.

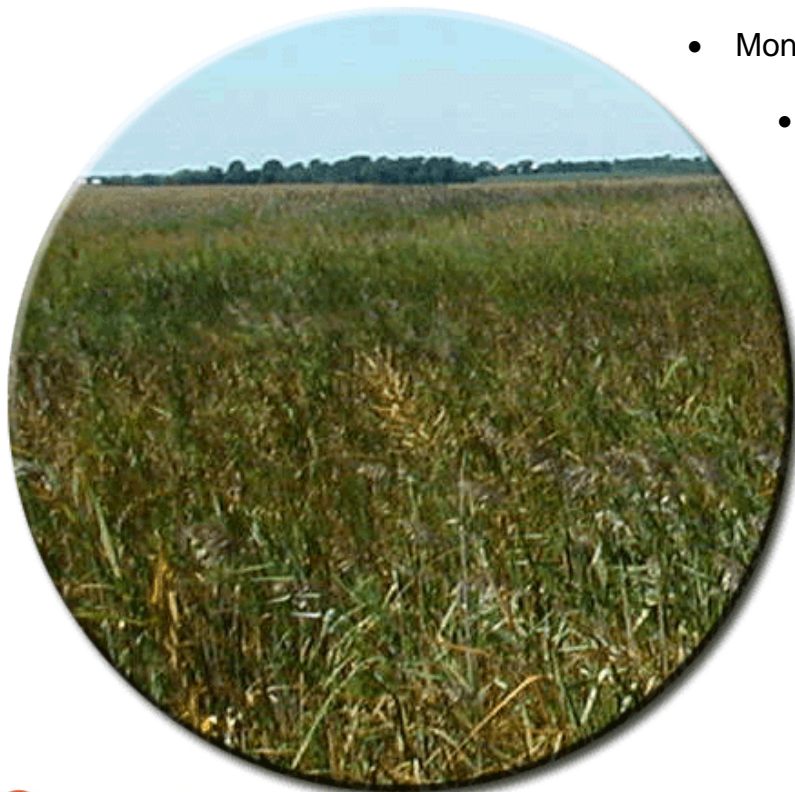
The Rocks Wetland Restoration Site Vegetative Cover Summary Chart

Prior to restoration activities, *Phragmites* (yellow line) covered 87% of the site; *Spartina* (green line) was present in very limited areas. After herbicide applications, *Phragmites* coverage decreased, and was replaced by *Spartina* and mixed stands of desirable species. *Spartina* and other desirable marsh vegetation now dominates more than 70% of the site. The red line (linear feet of channel per acre) indicates the increased aquatic habitat at this site.

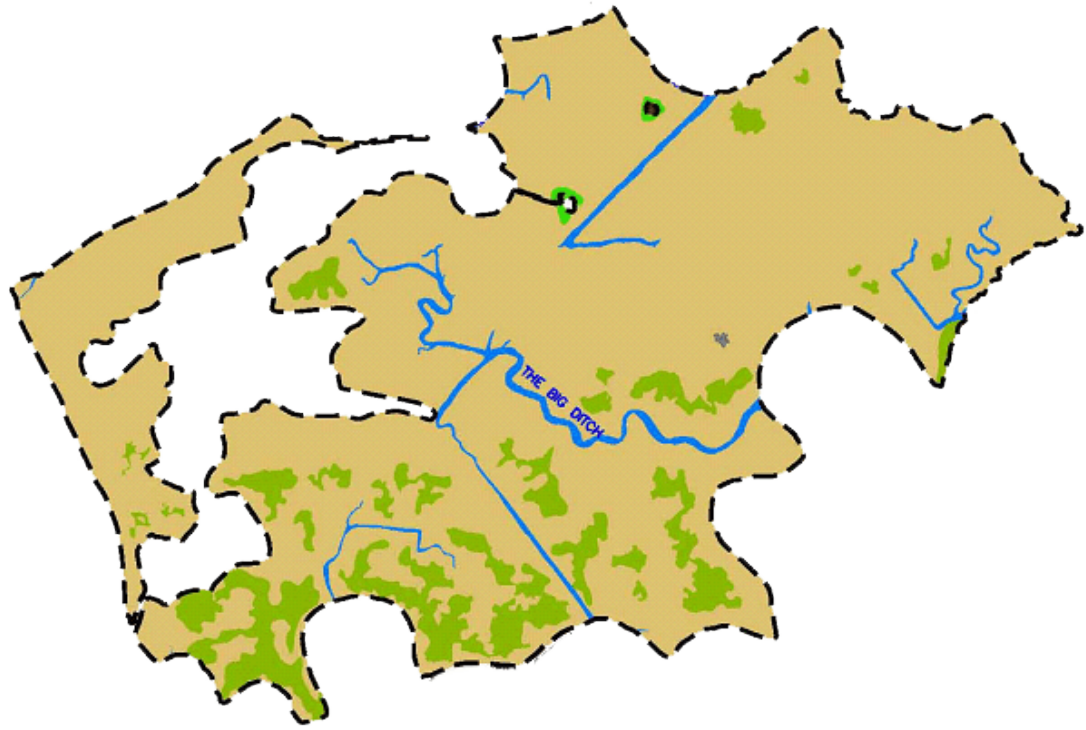
The Rocks Site – 1993

As shown by the tan shaded area, The Rocks *Phragmites*-dominated Wetland Restoration Site was dominated by *Phragmites* prior to restoration activities. Only scattered areas of *Spartina* and other desirable marsh vegetation (green shaded areas) were initially present. Small tidal channels were absent.

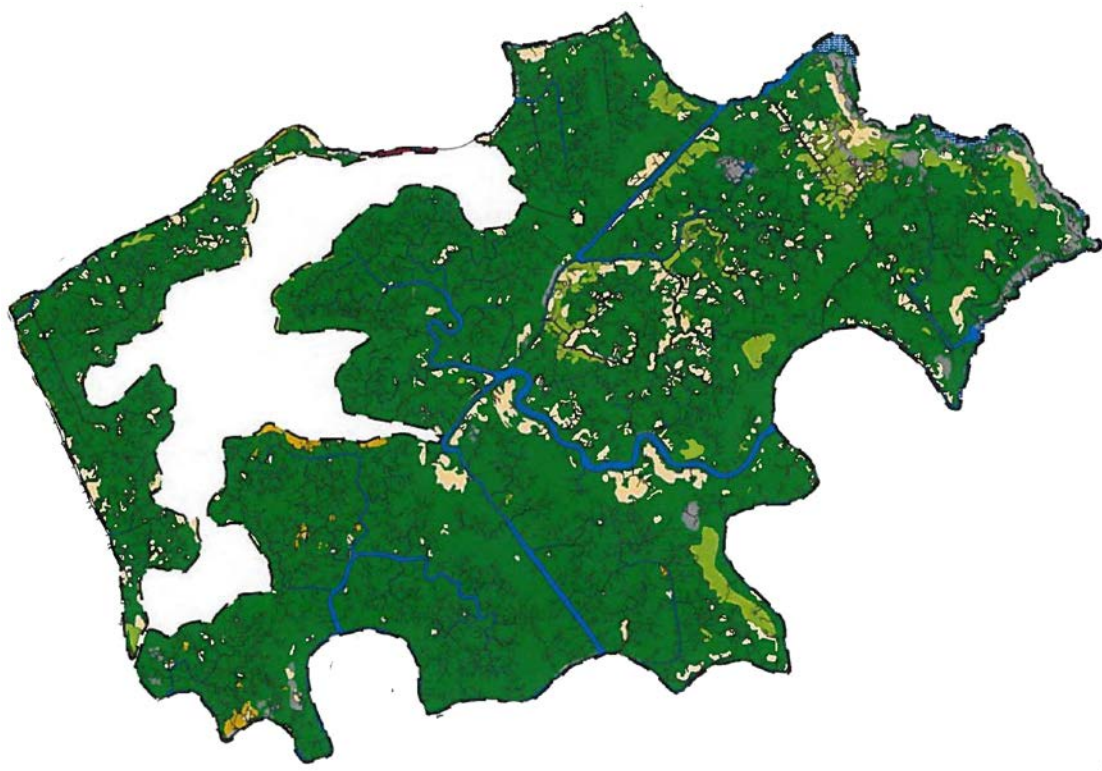
The Rocks Site – 2016

After treatment, the *Phragmites* (tan shaded areas) population declined. With improved drainage, *Spartina* (green shaded areas) increased, and now dominates the site.
