## Annual CCR Inspection Report

Hudson Generating Station, Jersey City, New Jersey

October 16, 2018  
Project 1504710

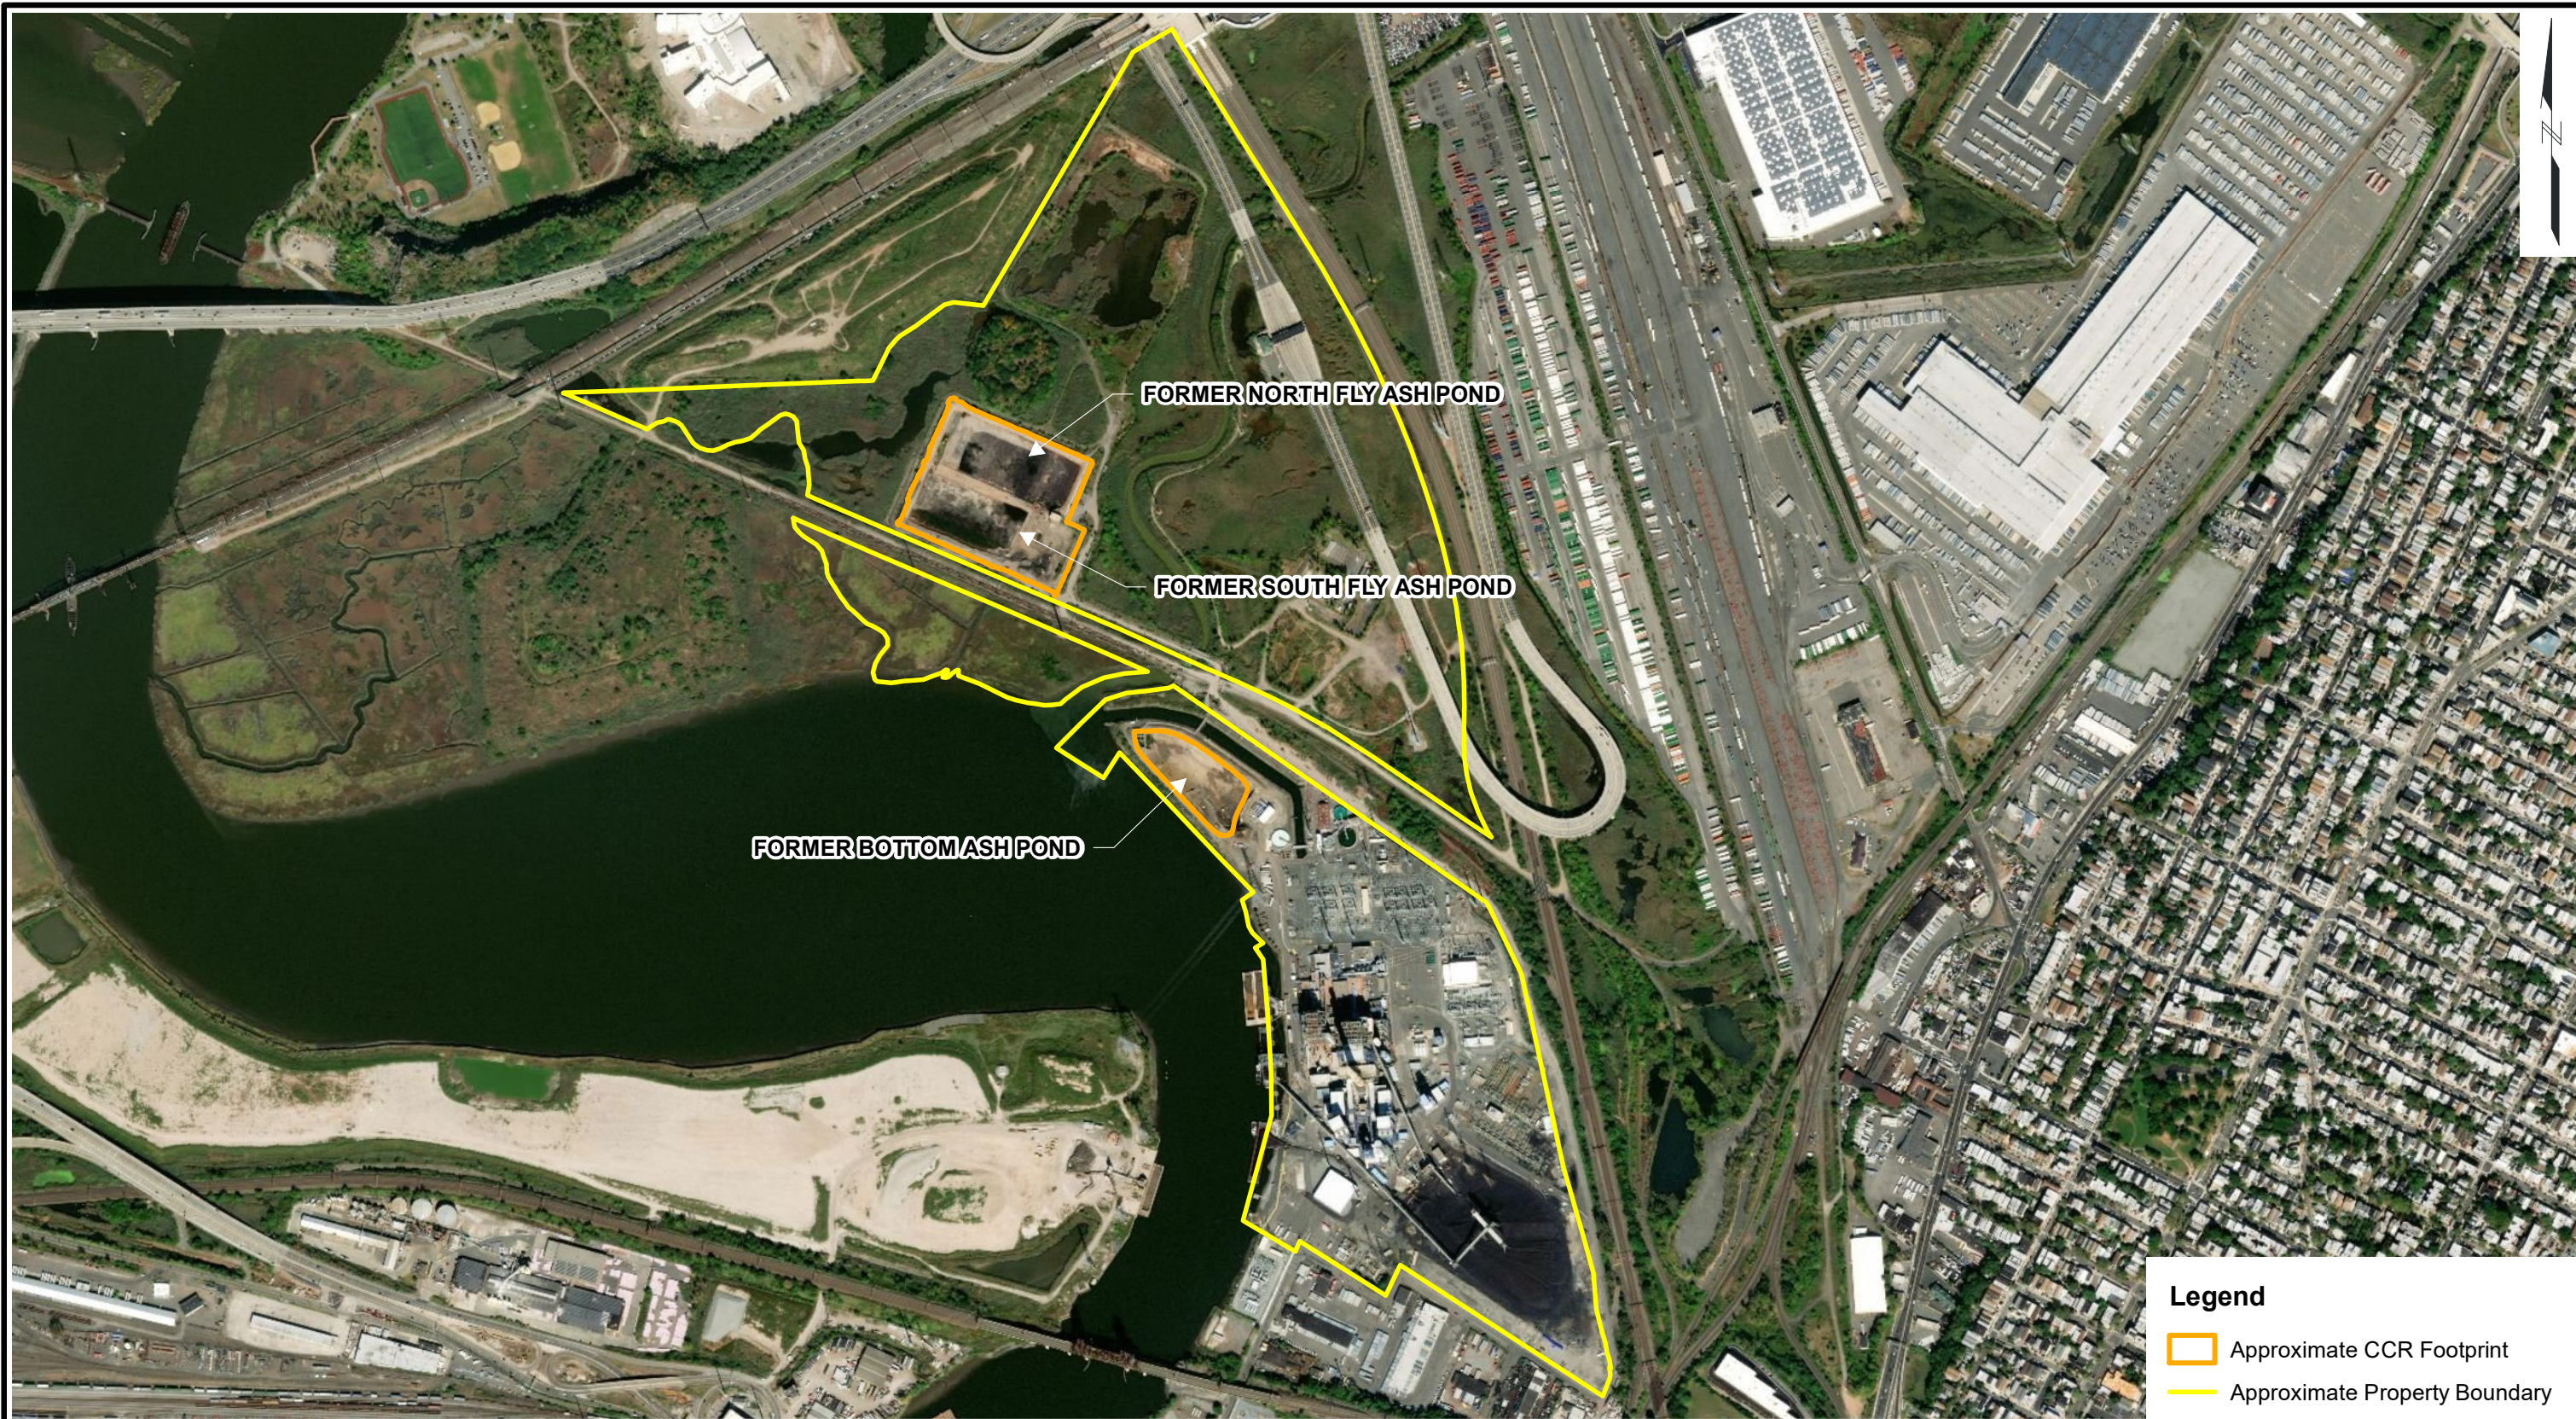
Fig. 2

**SOURCE:**  
1. AERIAL FROM ESRI WORLD IMAGERY - 2017.

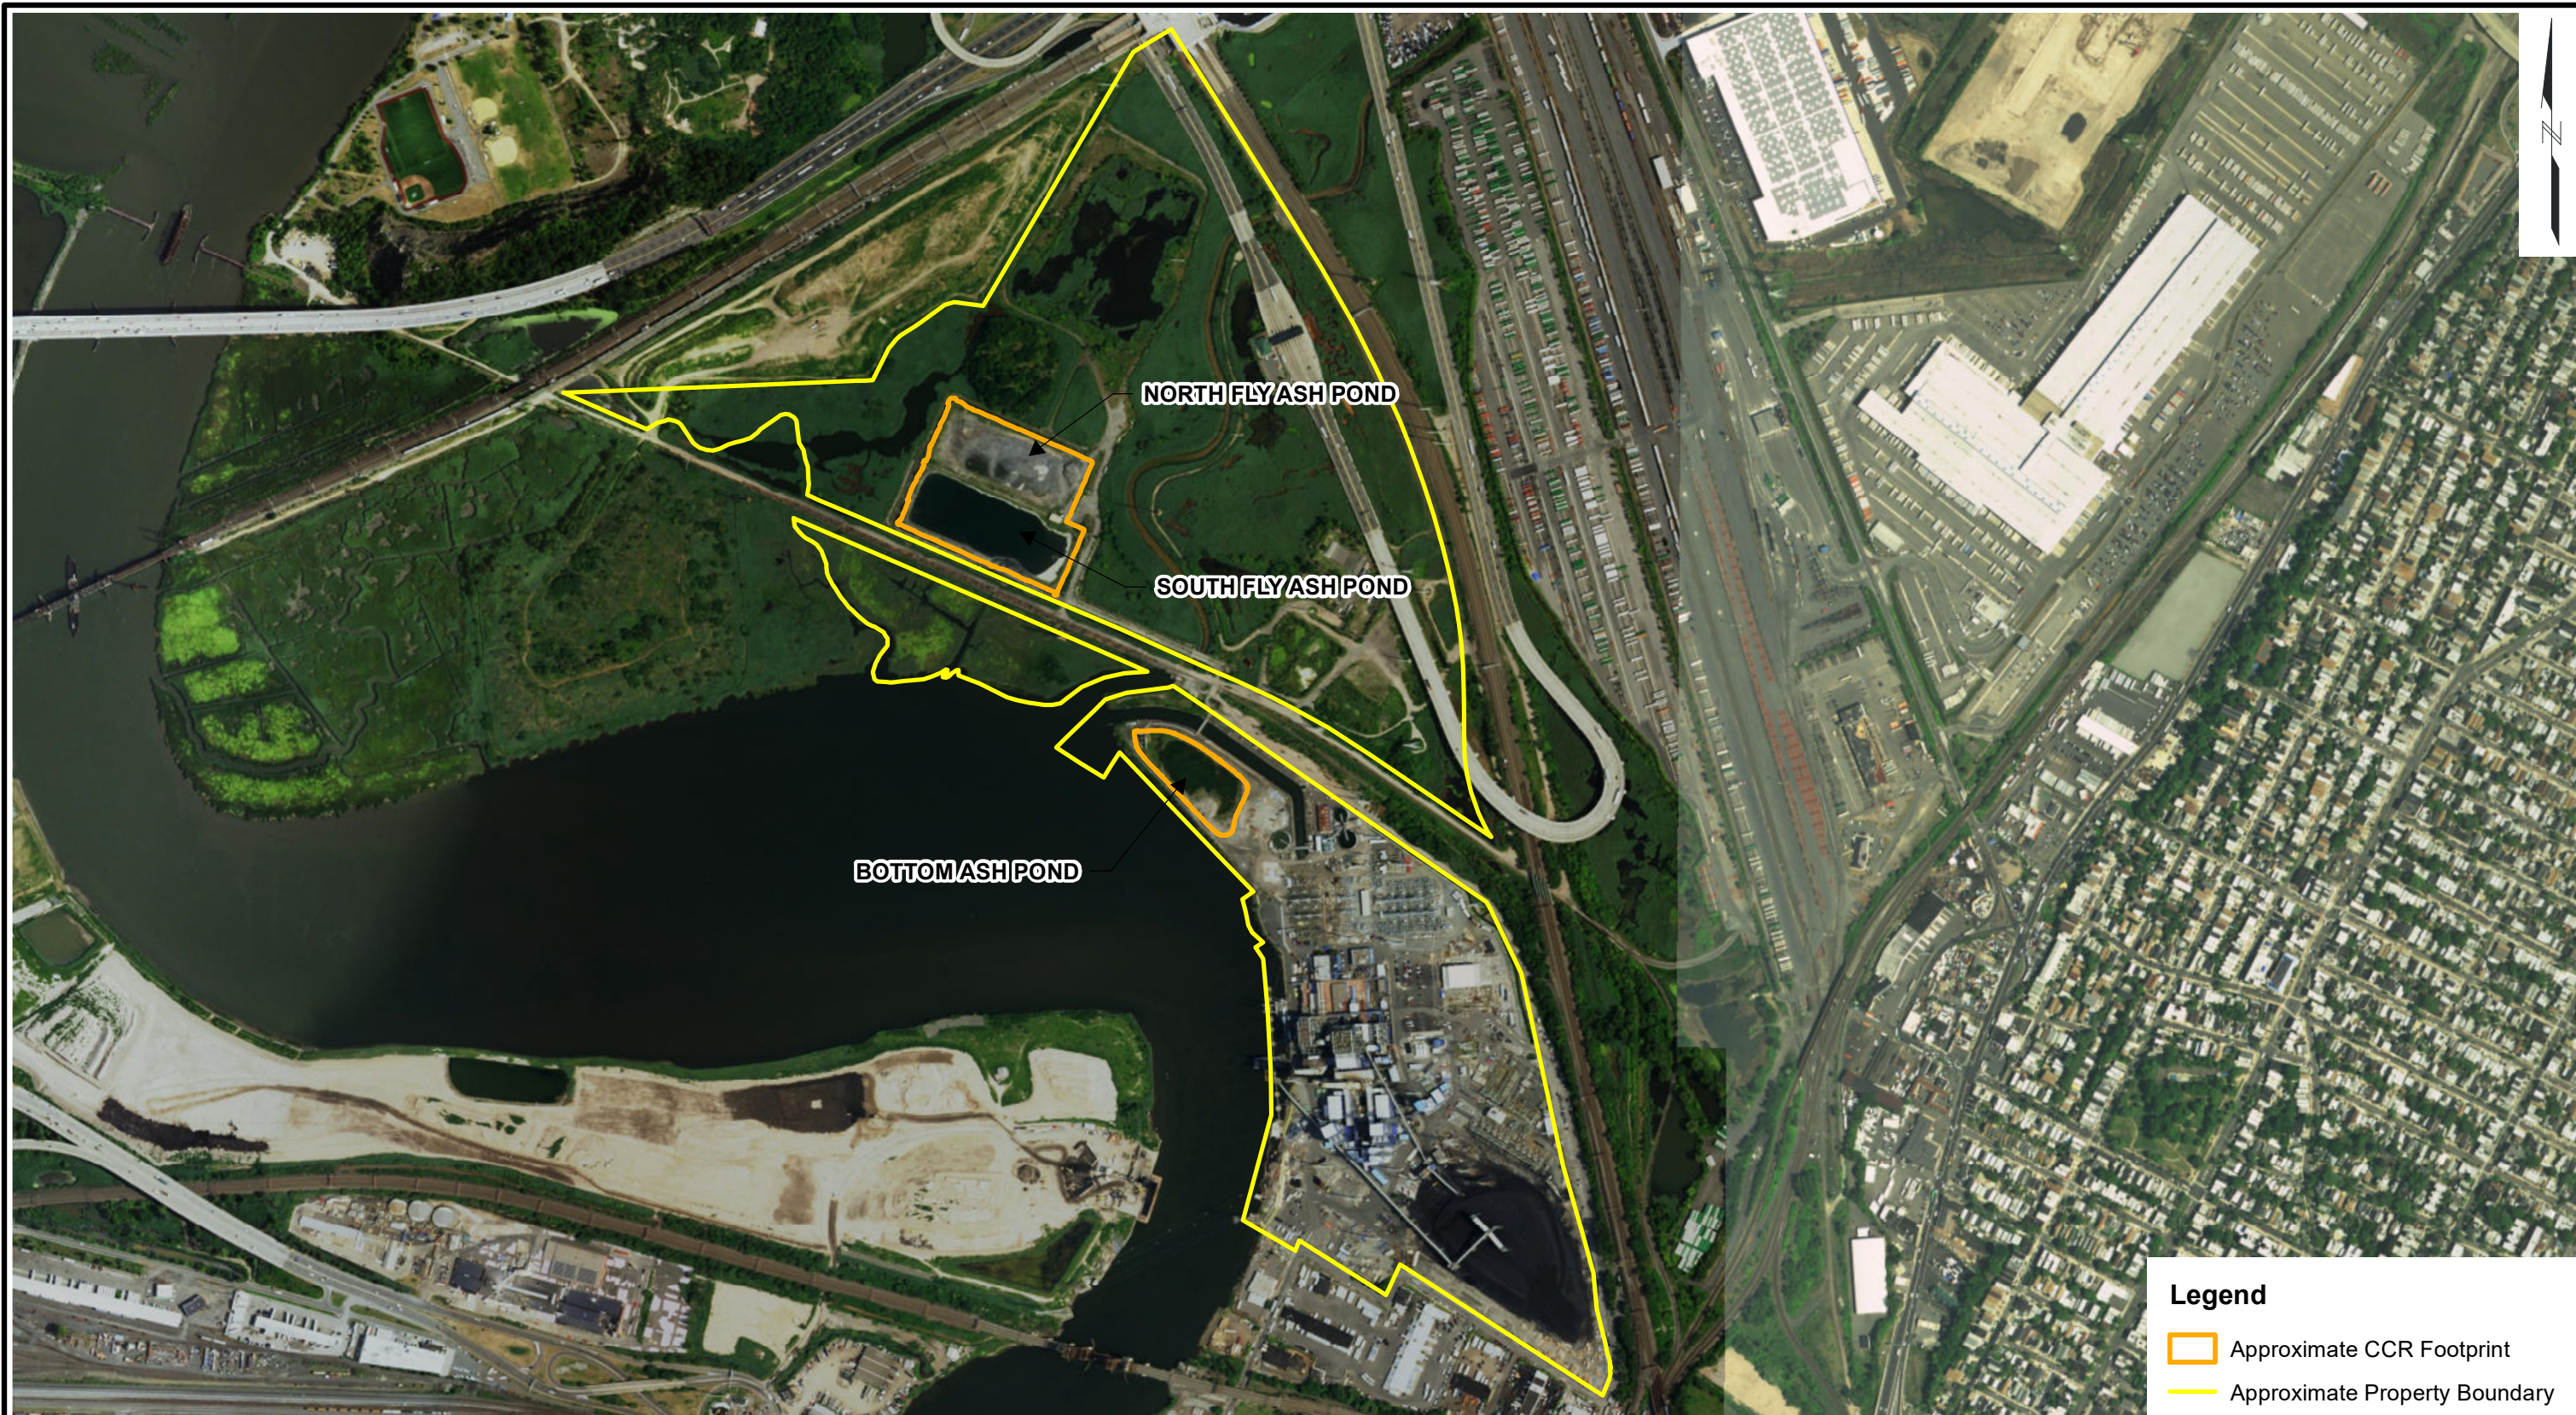
Fig. 2

**SOURCE:**  
1. AERIAL FROM ESRI WORLD IMAGERY - 2017.
