ESTUARY ENHANCEMENT PROGRAM

DENNIS TOWNSHIP SITE

# Dennis Township Wetland Restoration Site Vegetative Cover Summary Chart

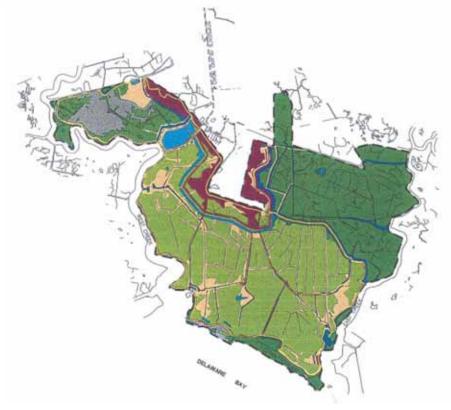
## **Dennis Township Site – 1995**

Spartina (dark green shaded areas) flourished in areas outside the salt hay farm; however, dikes present and the lack of tidal channels restricted favorable habitat within the farmed area. Some Phragmites (tan shaded areas) was present in farmed areas of the site.

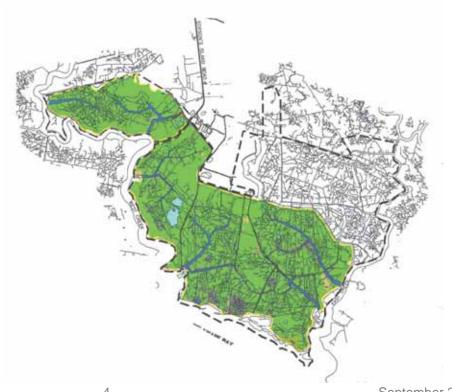
# Dennis Township Site - 2004

Removing dikes and dredging tidal channels restored habitat conditions favorable to Spartina (green shaded area) and the population now covers much of the formerly farmed areas. Phragmites (tan shaded areas) once present in the farmed areas has been nearly eliminated.
